Technical analysis of moisture transfer qualities of mildly sloping roofs

Ari-Veikko Kettunen, Senior Specialist, M.Sc.(Tech)
Vahanen Oy, Finland

- The research was funded by SAINT GOBAIN ISOVER LTD, FACTORY in HYVINKÄÄ, FINLAND
- The research target was the factory building's roof structure at the packing department expansion area.
- During the renovation construction, a heat insulation Isover OL-TOP-60/U (glasswool 60 mm) + OL-P-170 (glasswool 170 mm) and rubberized bitumen cover was placed on the old TT-tile.

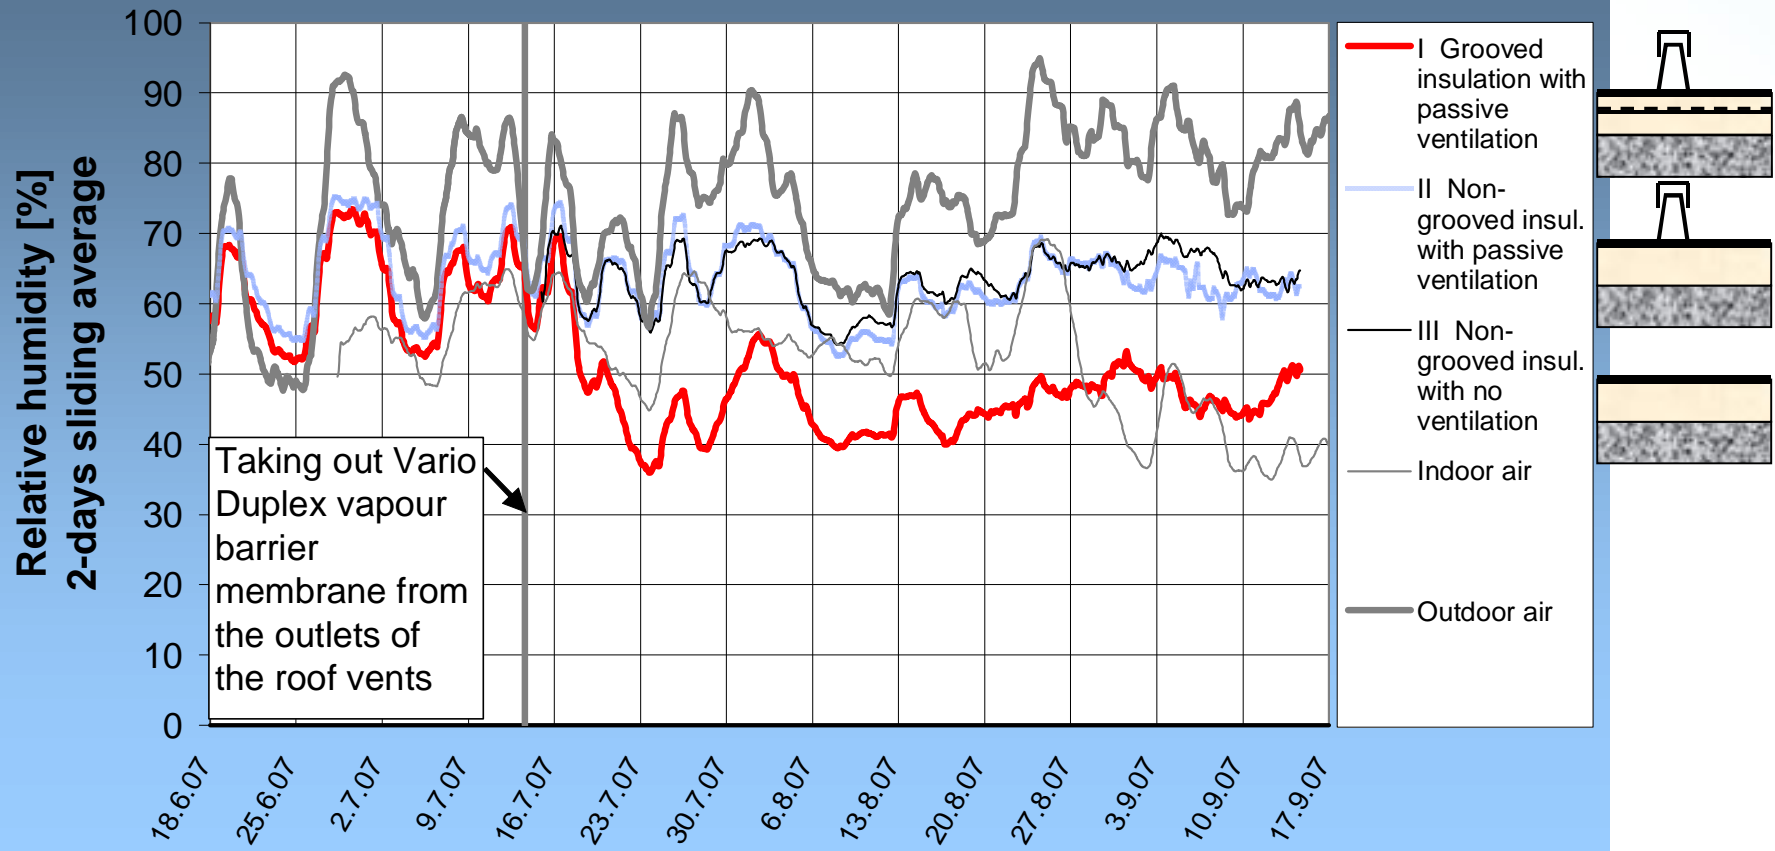
RELATIVE HUMIDITY OF AIR AT MEASUREMENT POINT 2B, HALF-WAY BETWEEN ROOF VENTS AT THE GROOVE DEPTH

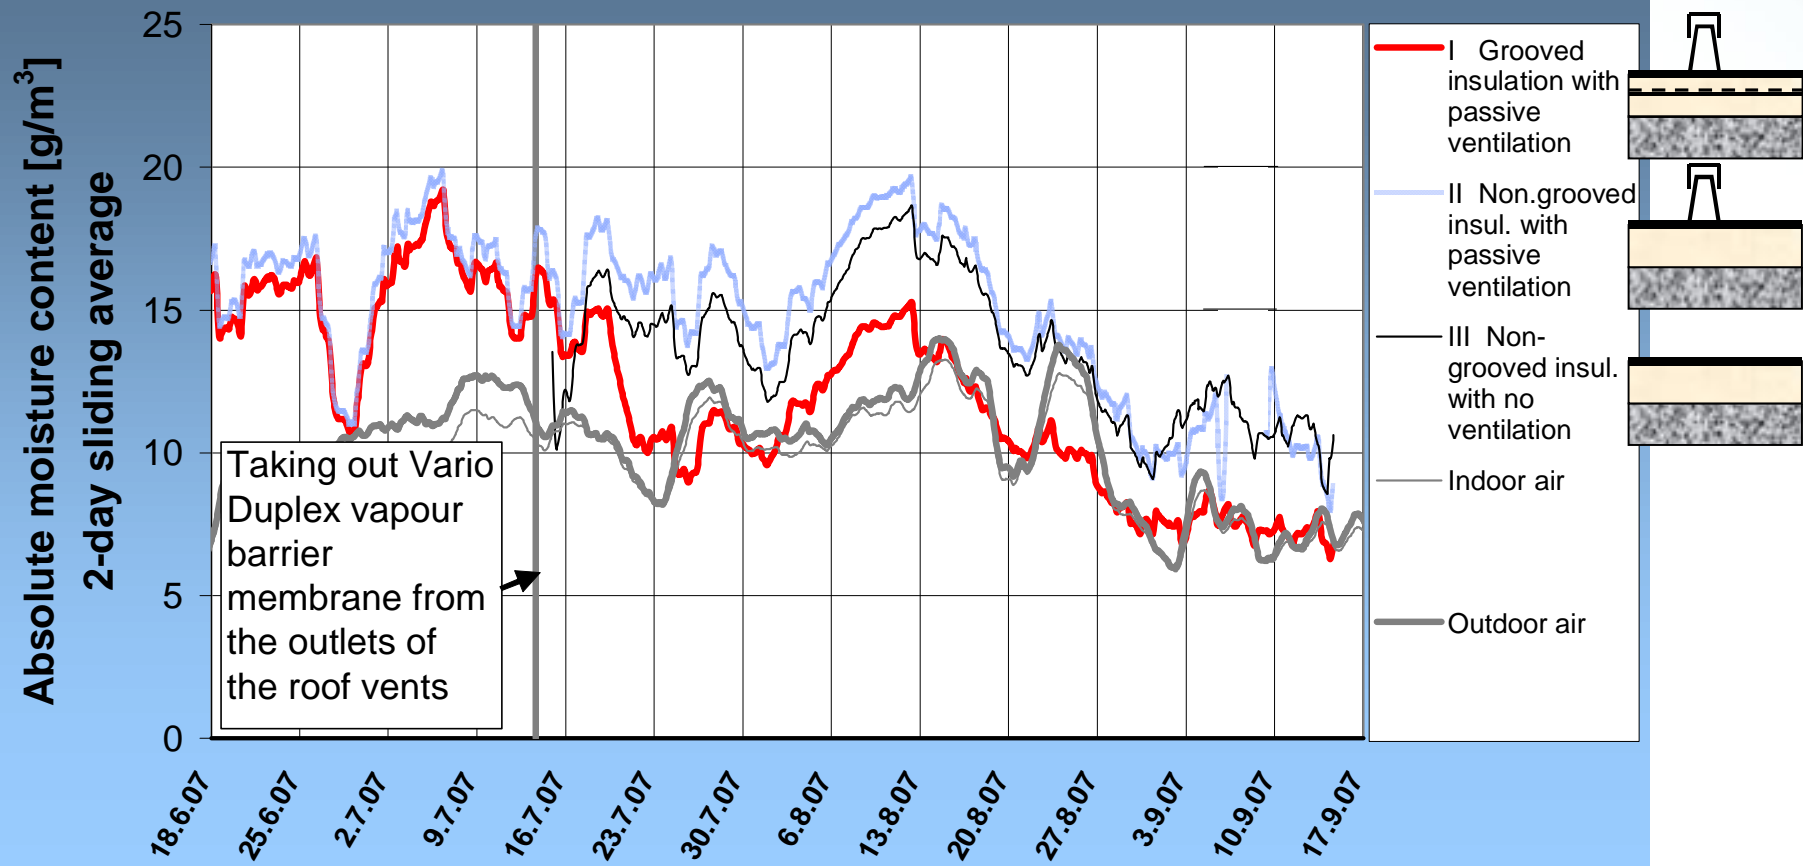
WATER VAPOUR CONTENT OF AIR AT MEASUREMENT POINT 2B, HALF-WAY BETWEEN ROOF VENTS AT THE GROOVE DEPTH

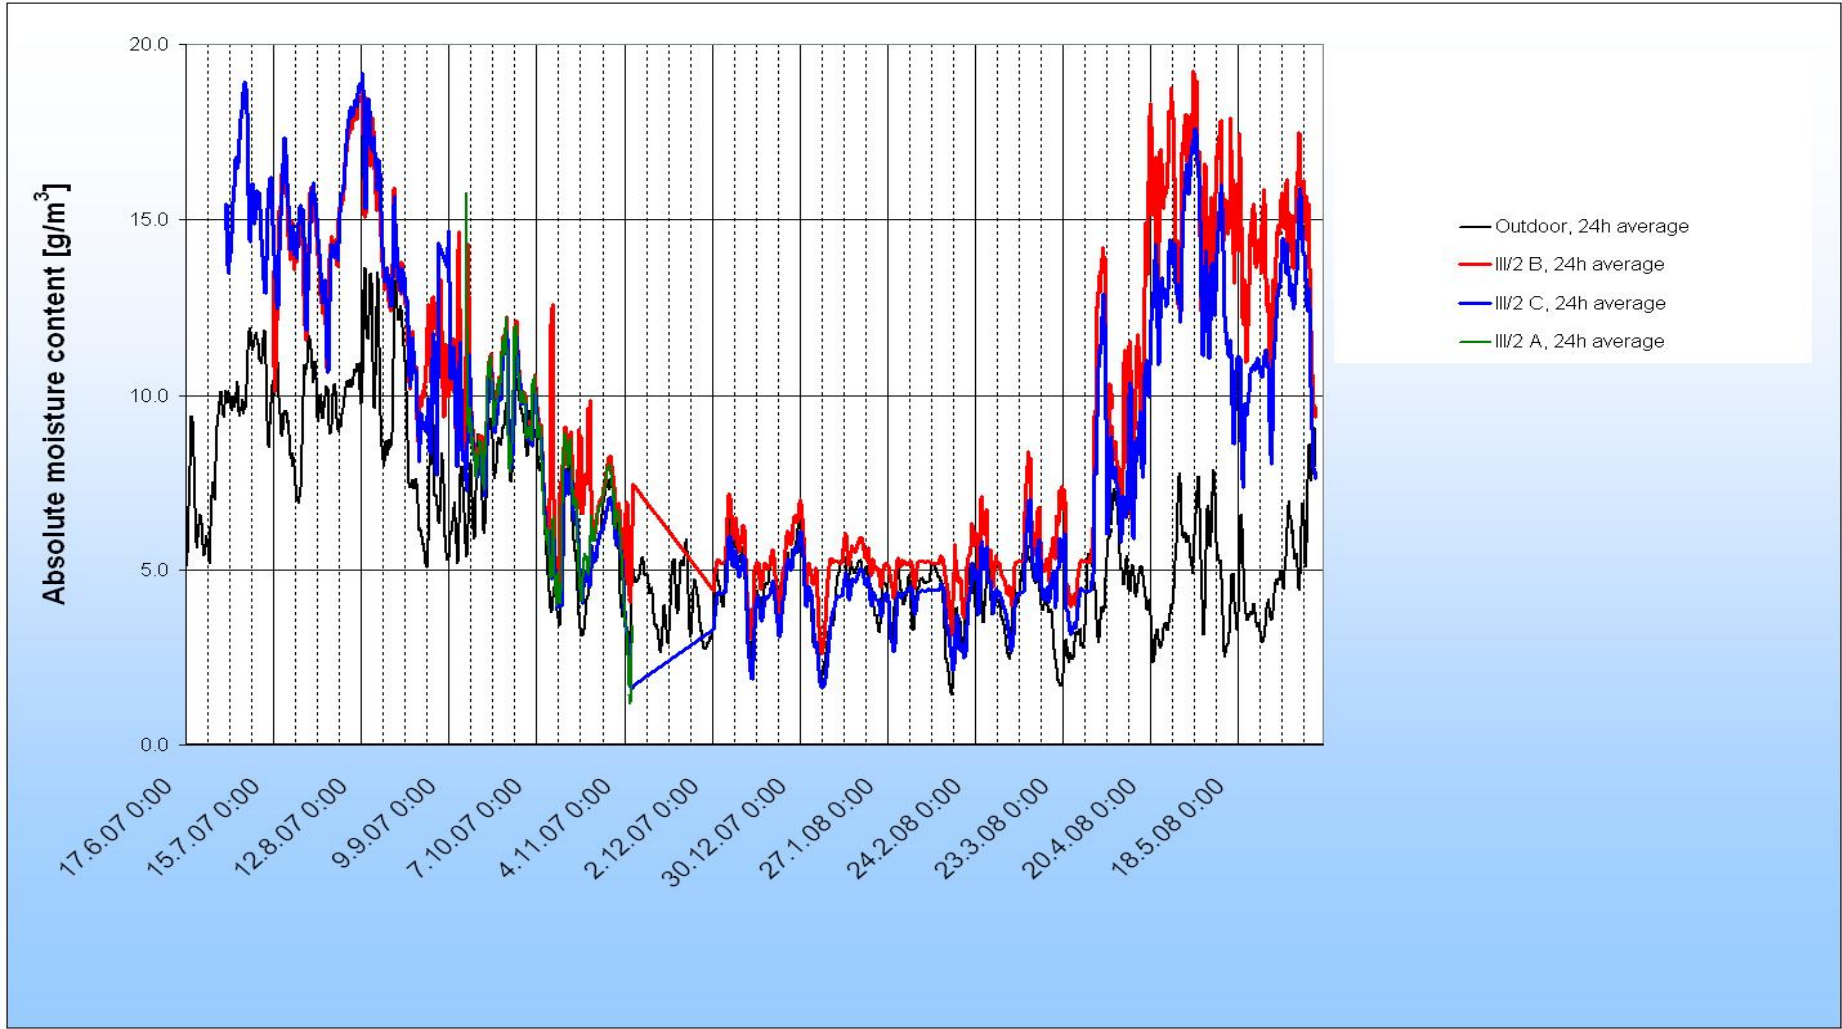
The absolute moisture content values between 17 June 2007... 11 June 2008 taken from the non-ventilated solid glasswool structure from points 2A, 2 B and 2 C.

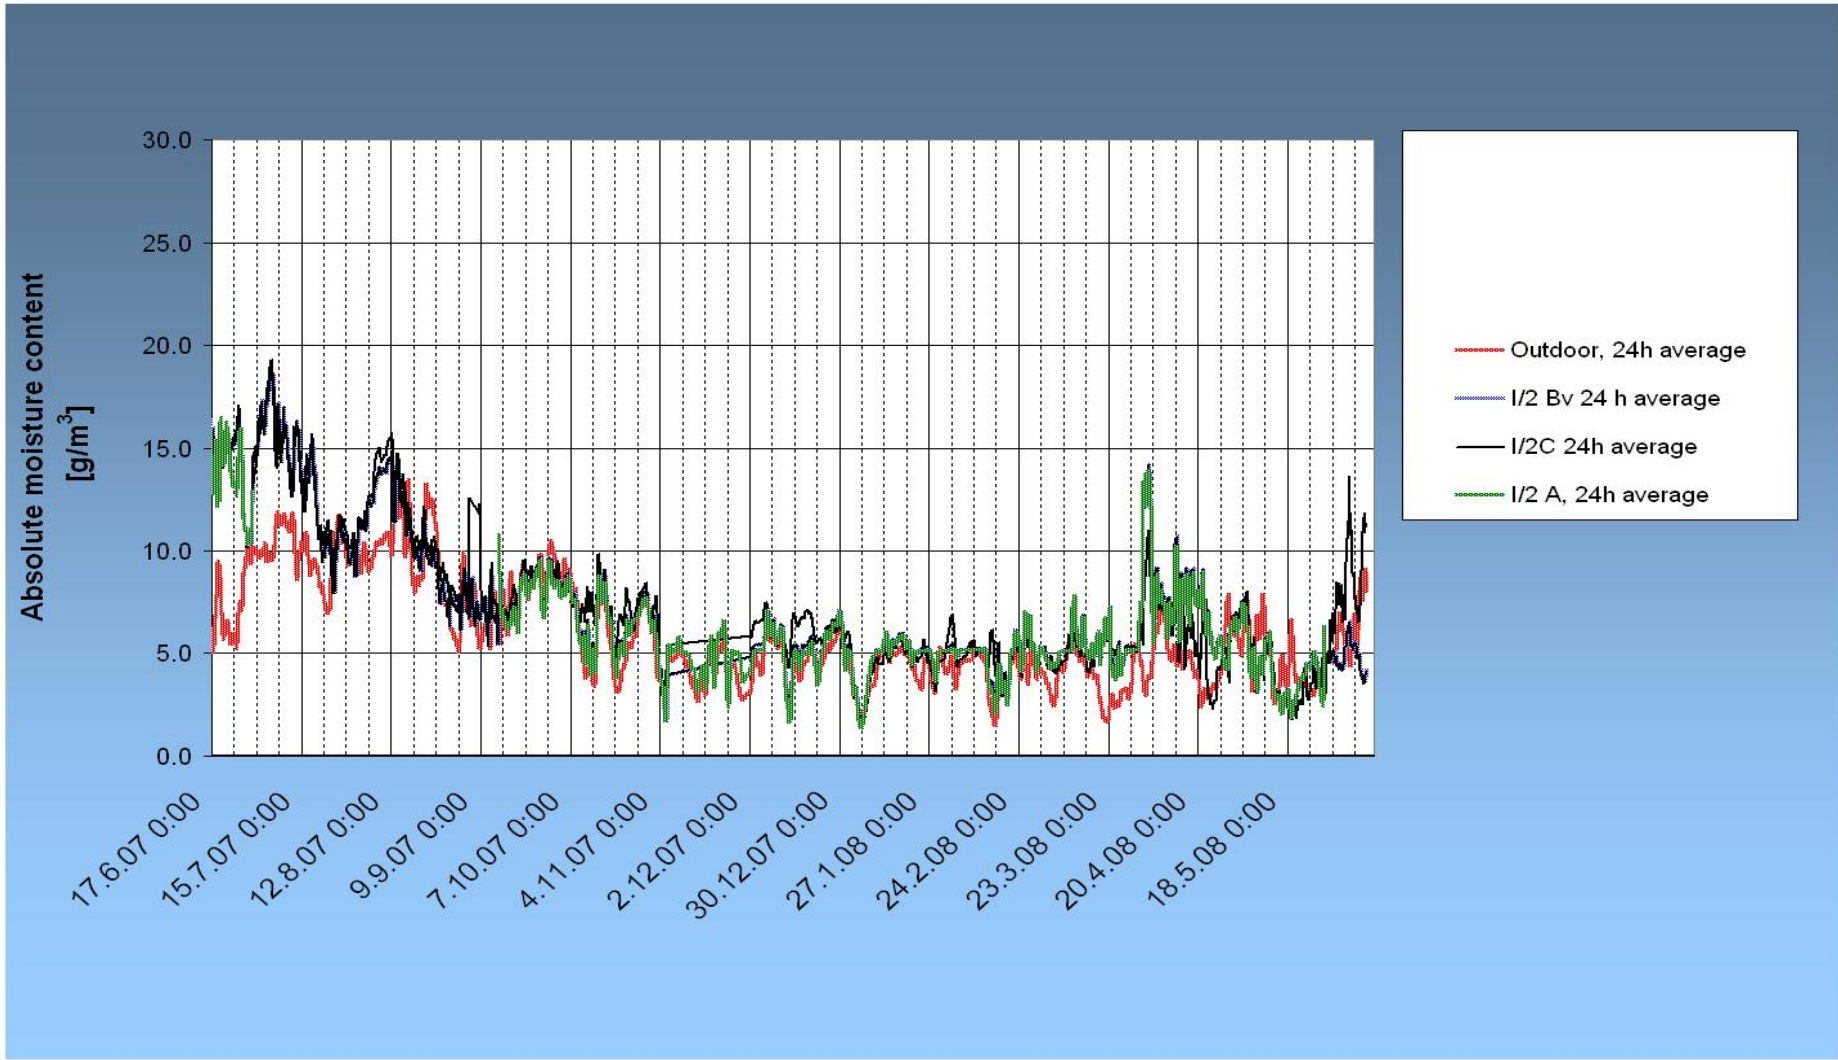
Absolute moisture content values between 17 June 2007 ... 11 June 2008 taken from the ventilated grooved glasswool structure from points 2A, 2 Bv (between the grooves) and 2 C. Roof vents opened 14.07.2007.
