Framtidens trähus Timber framed House of the Future

Moisture and mould in prefabricated timber frame constructions during production until enclosure of

Authors: Lars Olsson M.Sc., Kristina Mjörnell PhD, Pernilla Johansson M.Sc.
all from SP

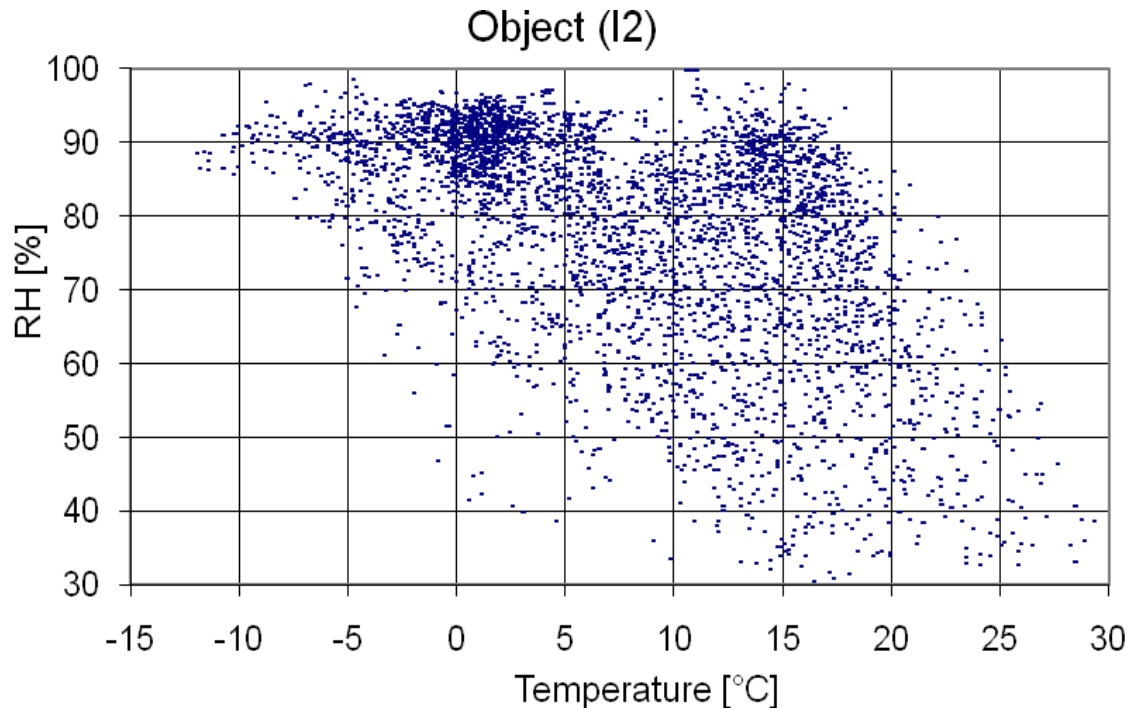
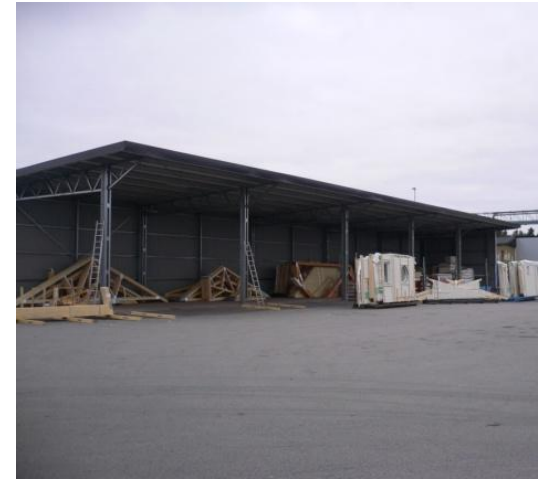
Outdoor timber store under cover

*Climate conditions were recorded every second hour (**each point represents two hours**) over almost a year from December 2008 until November 2009.*

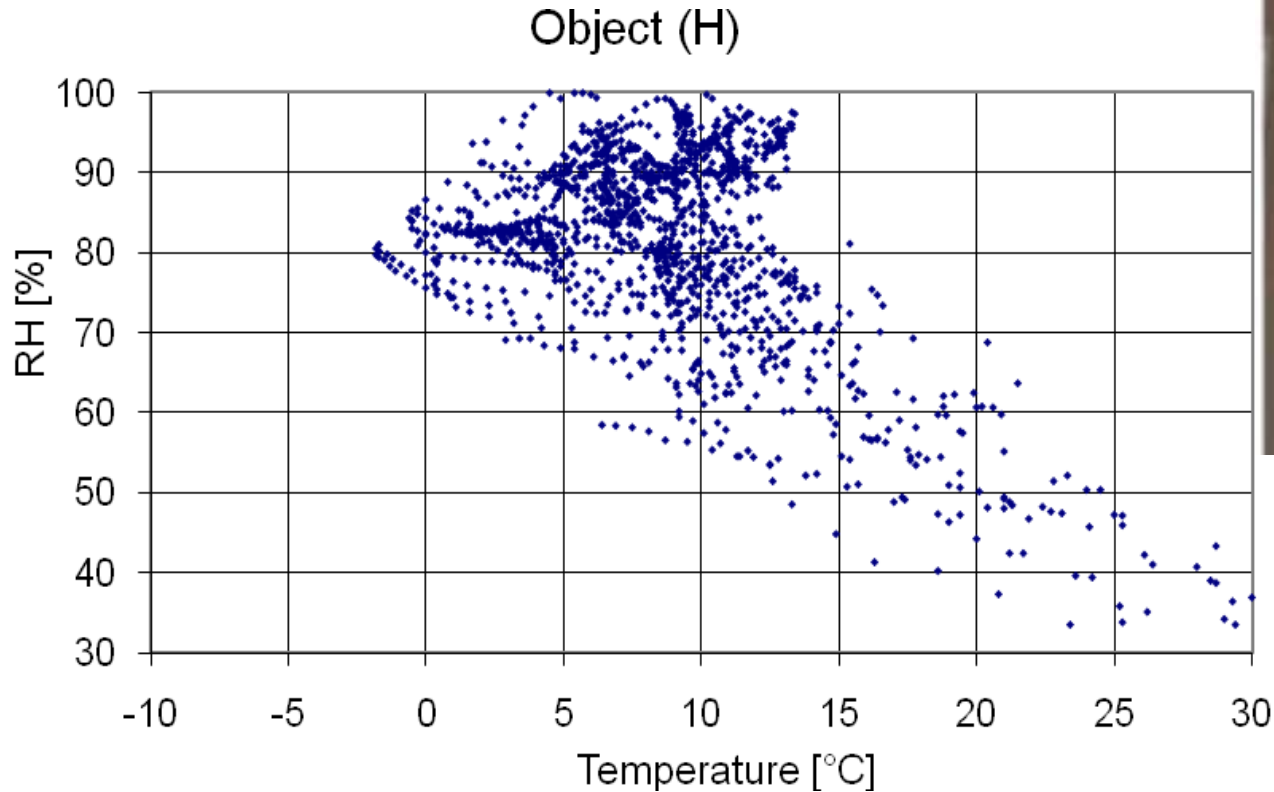
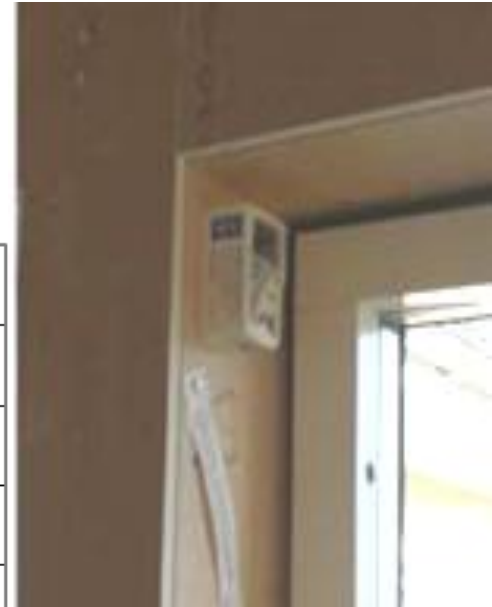
Wall element/building object (H)

Climate conditions were recorded each hour (each point represents one hour) from 24th September 2008 to 21st November 2009 on wall element/building object (H).

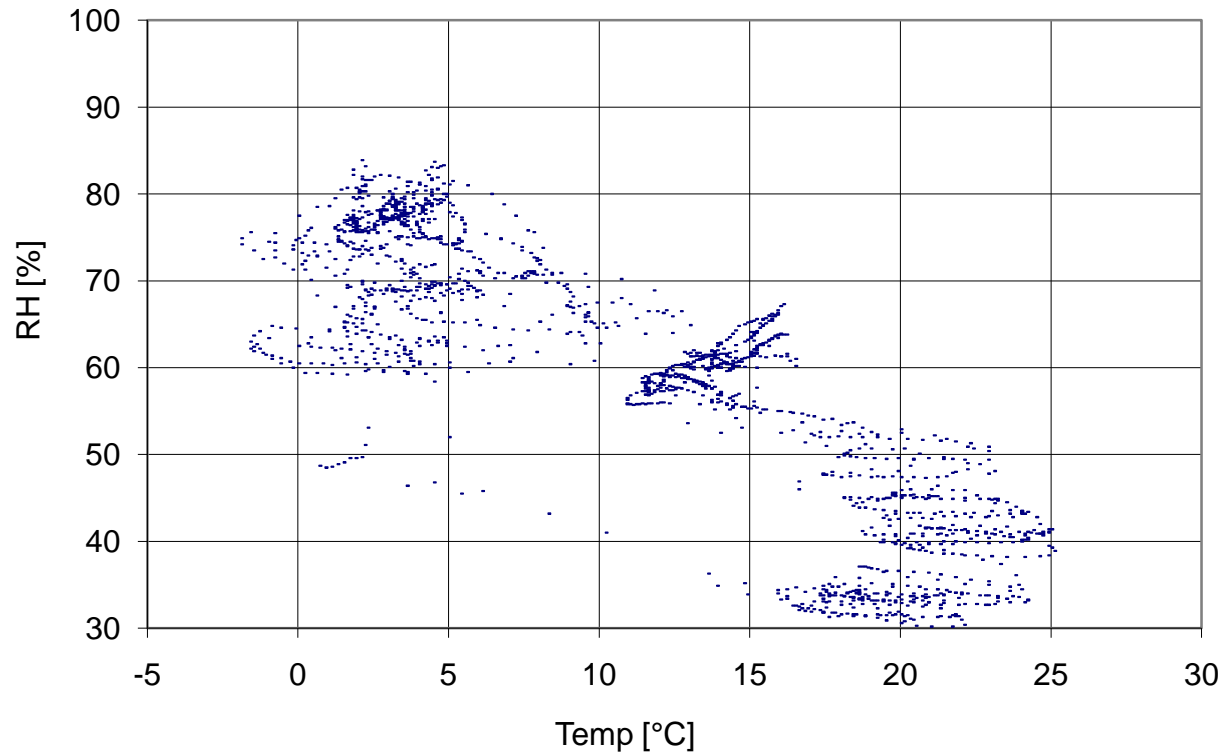
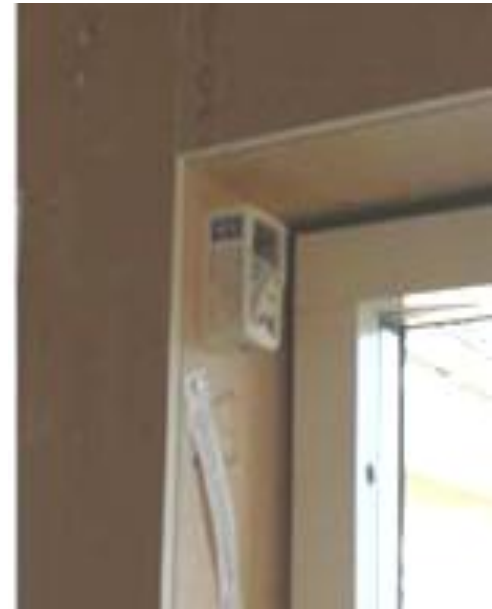
Wall element/building object (J)

Climate conditions were logged each hour (i.e. each point represents one hour) from 19th September 2008 to 4th December 2008
