Deterioration of building envelope of wooden apartment buildings built before 1940 based on external survey

Paul Klõšeiko, Tõnis Agasild, Targo Kalamees Chair of Building Physics and Architecture, Tallinn University of Technology, Estonia

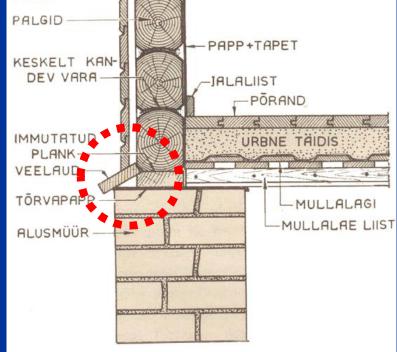
Typical area for damage: the rows first of the log of the external wall;

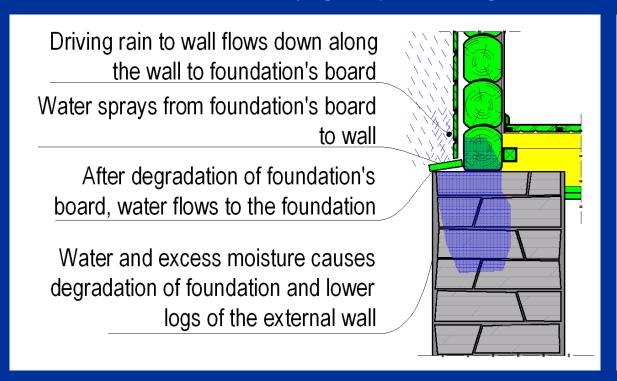
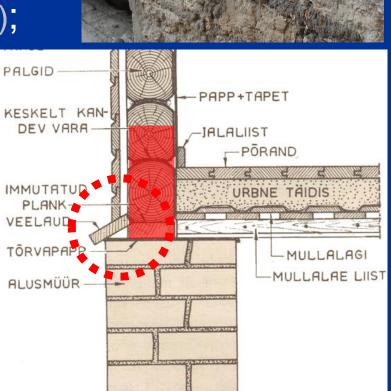
- Typical area for damage:
 the rows first of the log of the external wall;
- In renovation of buildings, the Heritage Board requires original solution

(despite that was partly guilty on degradation);
