Methods for Investigation of Technical Status Before Renovation and Evaluation of Renovation Measures for the Building Envelope

Kristina Mjörnell and Thorbjörn Gustavsson, SP,
Angela Sasic, Chalmers University of Technology

Milparena project – “Million Homes Program” arena

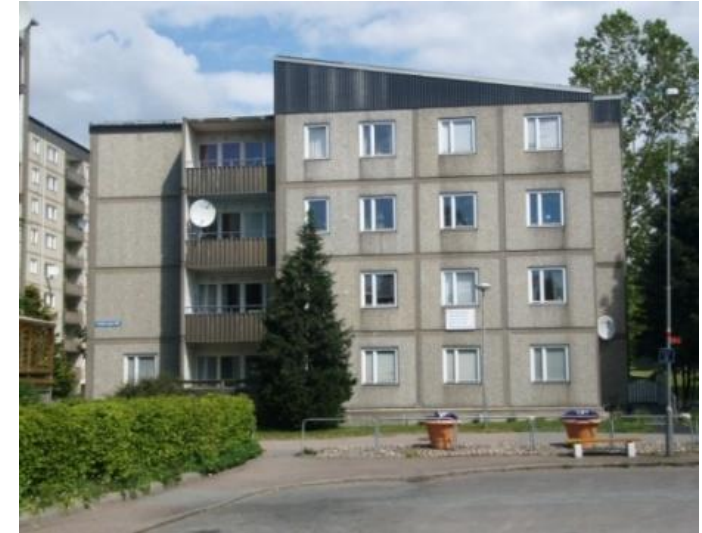
- Prefabricated concrete facade elements
- Carbonation and leakage
- Air leakage, draught from infill walls
- Thermal bridges and cold floors
- Energy use: 178 kWh/m², year

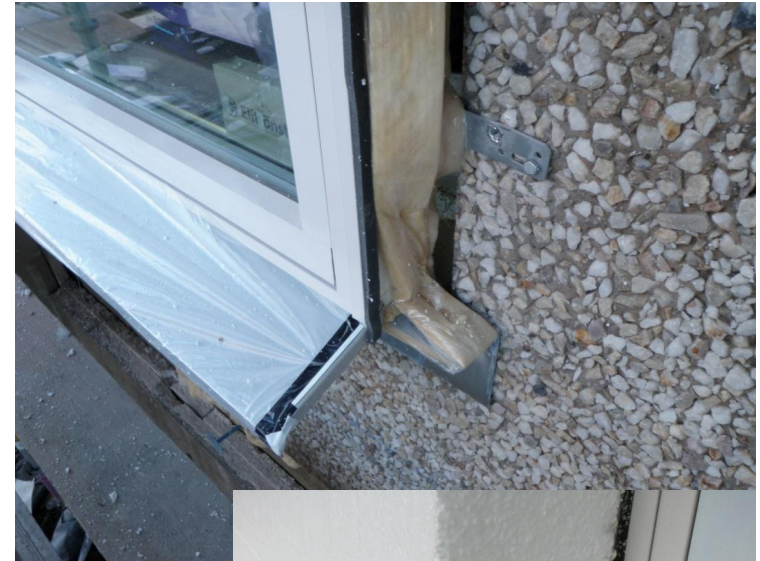
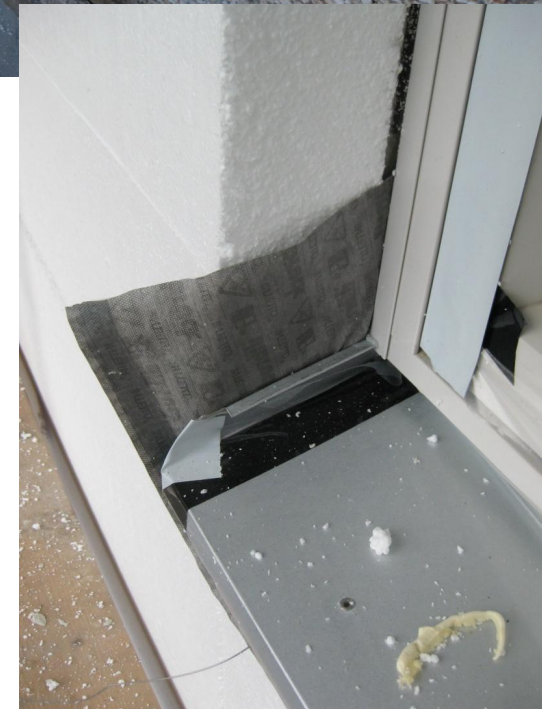
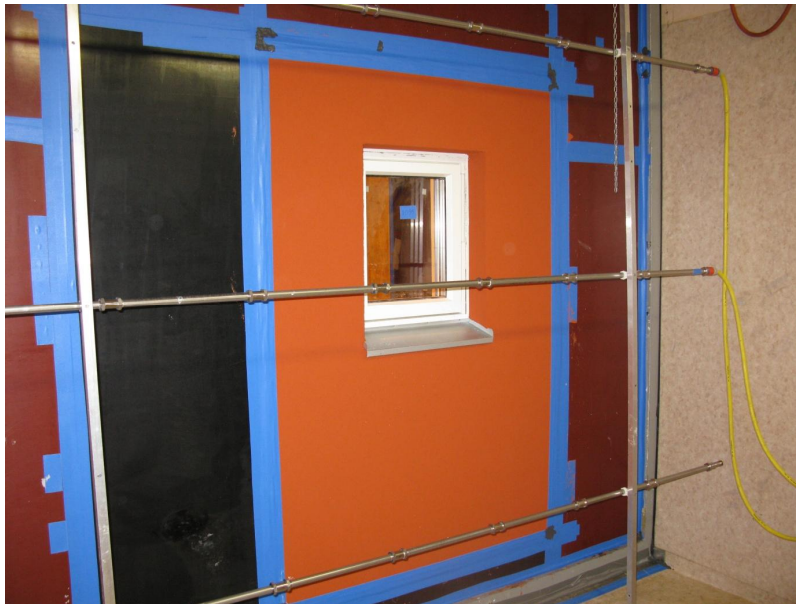
- Moisture inspections
- Insufficient rain tightness at window connections
- Confirmed by tests in the lab
- A new solution was developed and verified through lab tests.

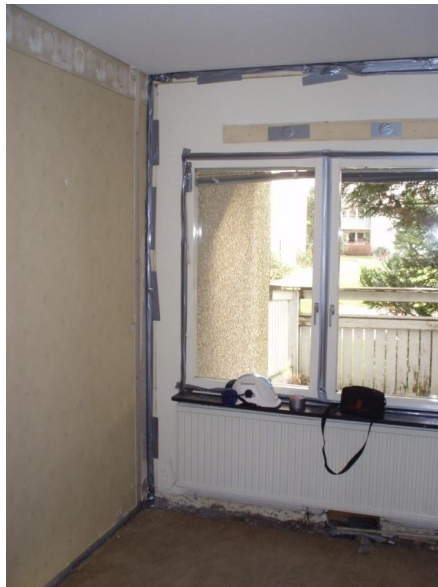
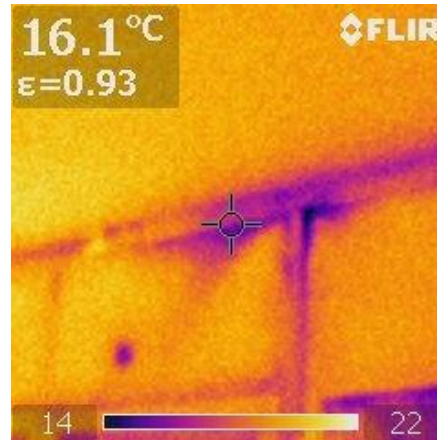
- Thermography, air-tightness measurements (Blowerdoor) and detection of leakages in existing, empty and in completed apartments
- Advice and following up on sealing methods
- Before: 1,18 l/sm² for one apartment
- After: 0,13 l/sm² for the whole building

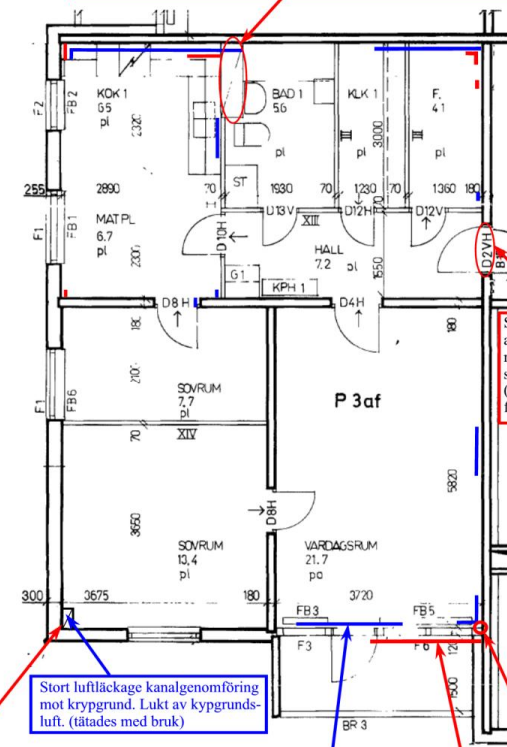
— Luftläckage vid golvvinkel (många av dem tätades tillfälligt med drev eller fog)
 — Luftläckage vid takvinkel

Luftläckage fanns både i tak- och golvbjälklag samt vägg i schaktet.
 Vid golv och vägg främst vid kanalgenomföringar genom betongen, i tak allmänt något otätt.

Stora luftläckage både i anslutning dörrblad-karm, mellan tröskel och golv samt genom brevvinkast (tätning minskade luftflödet 20 l/s)

Stort luftläckage kanalgenomföring mot kryppgrund. Lukt av kypgrunds-luft. (tätades med bruk)

(Drevades extra, blev ej tätt men luftflödet minskade 10 l/s)

Luftläckage vid kanalgenomföring i mellanbjälklagbjälklag, både ovanifrån och utifrån (tätades huvudsakligen)

Avser läckage när även vertikal list samt taklist avlägsnats, ökade läckaget med ca 7 l/s. (taklist sattes tillbaka)

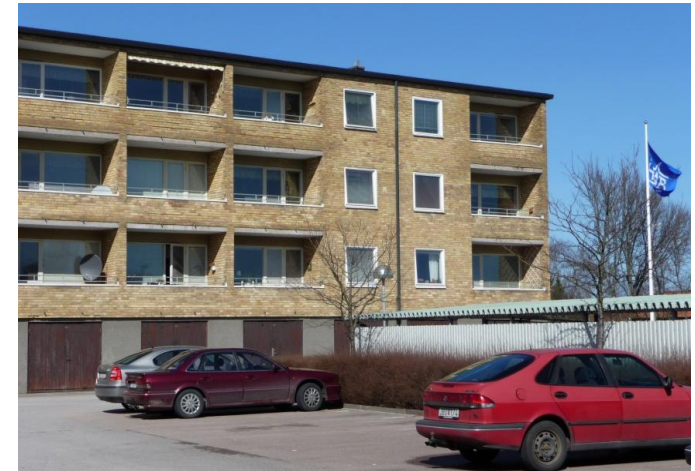
- Air leakage, draught from infill walls
- Thermal bridges and cold floors
- Corrosion in brick façade above windows and at balconies
- Energy use: 145 kWh/m², year

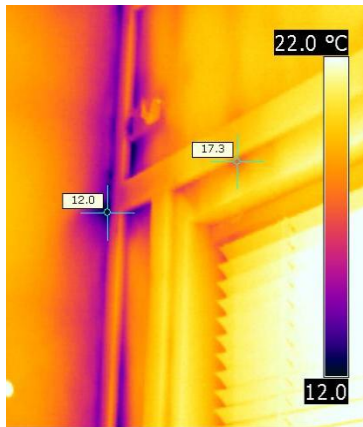
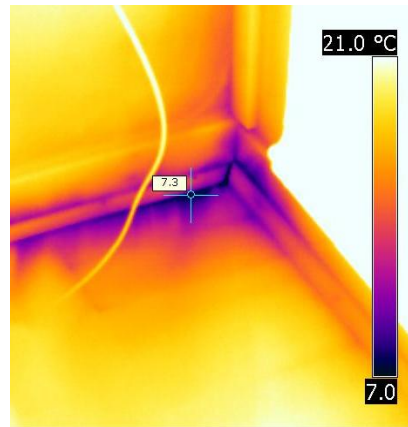
- Thermography and air-tightness measurements and detection of leakages in existing and completed apartments
- Before: 1,41 l/sm²
- After (design value): 0,5 l/sm²
- After (measured): 0,86 l/sm²
- There are still some leakages at window connections and at infill walls.

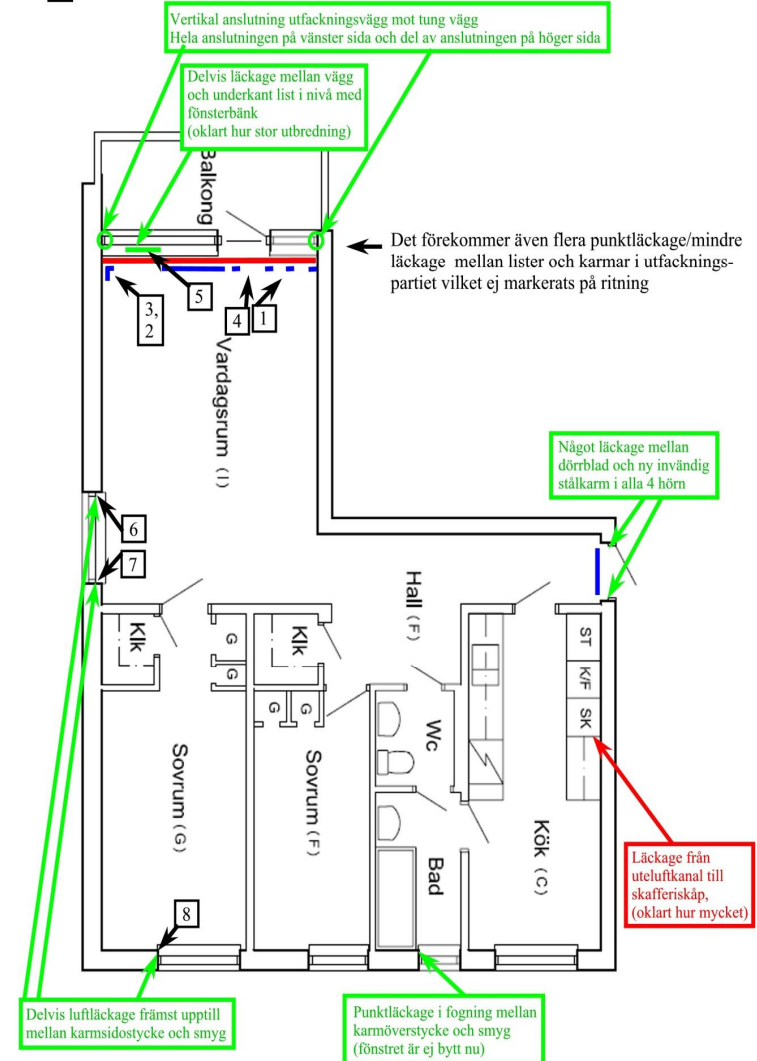
Lgh 170-017-05-0401

- Luftläckage vid golvvinkel (OBS enbart läckage som verifierats vid denna mätning, gamla läckage i golvvinkel som ej åtgärdats och ej kontrollerats denna gång är ej medtagna)
- Luftläckage vid takvinkel

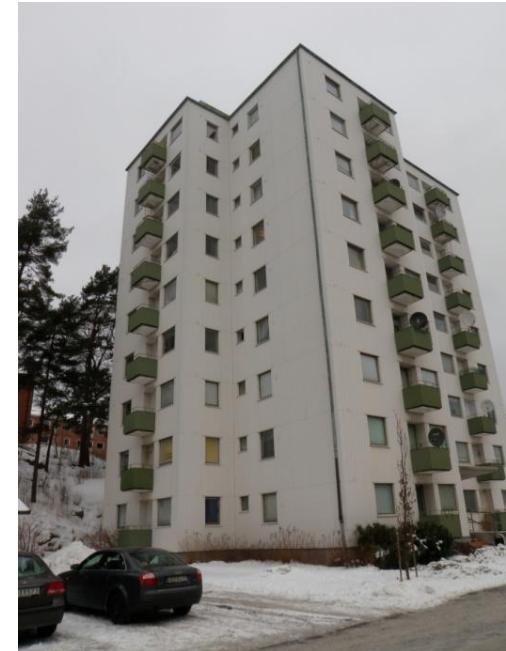
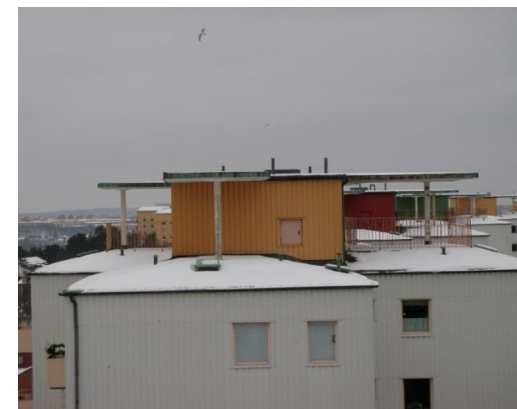
- Concrete and lightweight concrete walls with insufficient insulation
- Windows are in poor condition
- Ongoing roof leakage
- Carbonation and corrosion on balcony slab and on roof above the roof deck
- Energy use: 196 kWh/m², year
