Frost Damage in Roof Tiles in Relatively Warm Areas in Japan

Water Absorption and Freezing-Thawing Experiments

Chiemi IBA

Shuichi HOKOI

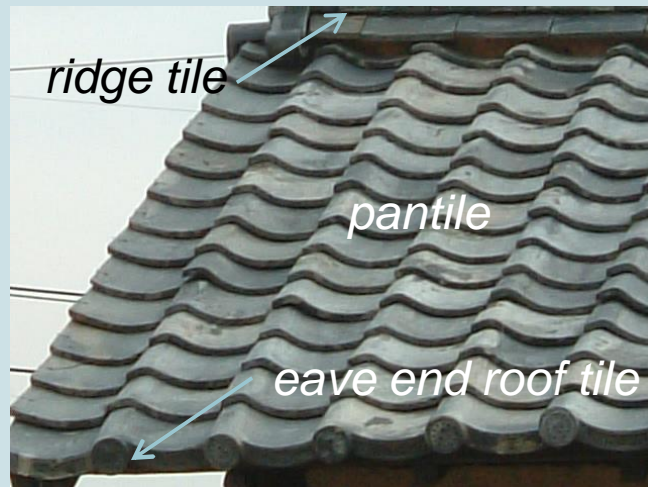
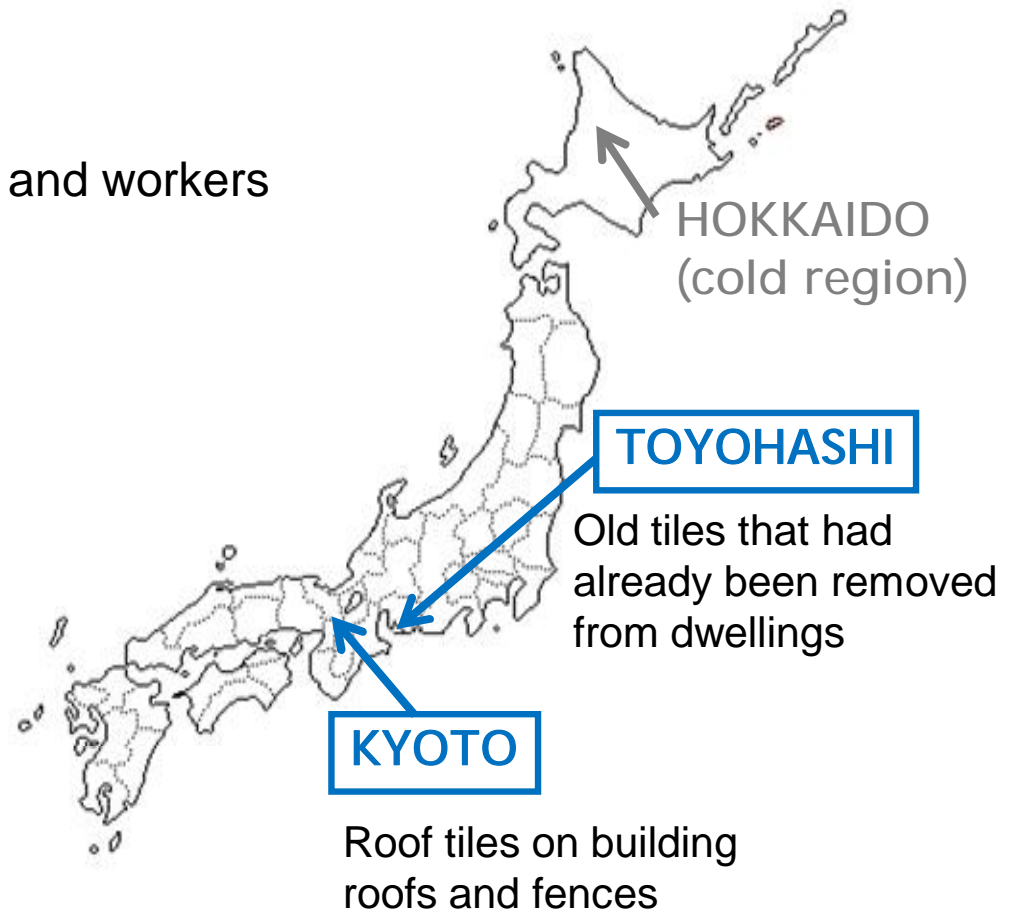
Various types of roof tiles

■ Typical deterioration (survey in Kyoto)

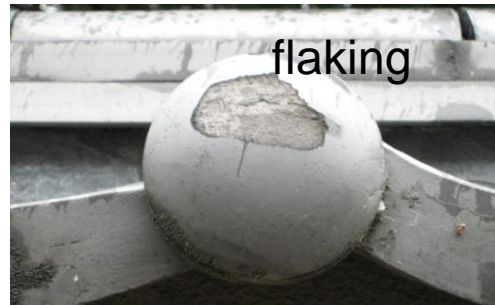
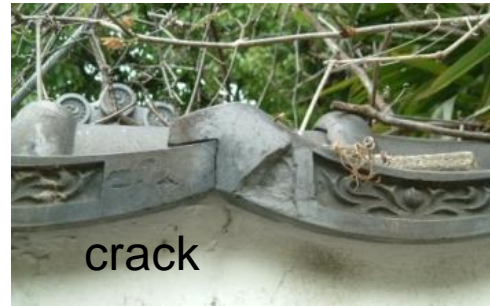
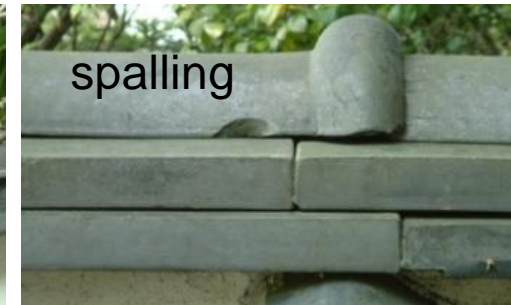
**Frost
damage ?**

Minor circular spillings

- ◆ The field survey showed that minor spalling seems to be typical of damage caused by freezing.
 - ◆ Characteristic damage could not be simulated by a standard freezing-thawing test. Thus, the standard test might be unsuitable for evaluating actual roof tile damage.

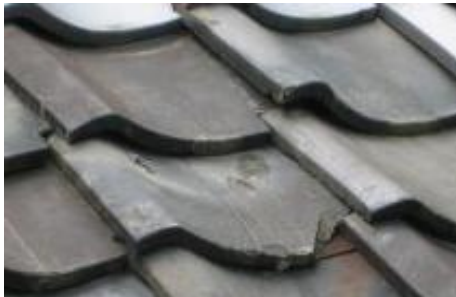
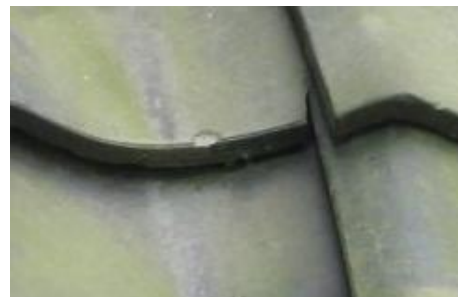
KYOTO

Old pantiles removed
from the dwellings

Rain water, which penetrate into the tile body through the areas of spalling, can accelerate the frost damage.

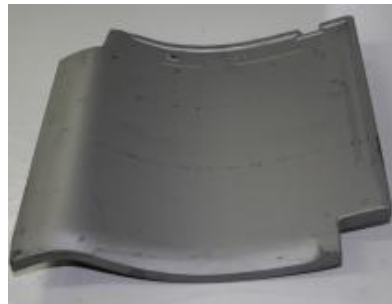
Pantile

- Purpose of standard freezing-thawing test is to examine the characteristics of frost damage in roof tiles.
- Test specimens: **Silver oxidized roof tiles** (Firing temperature: 1,070 °C) covered with a thin carbon film as a waterproof surface

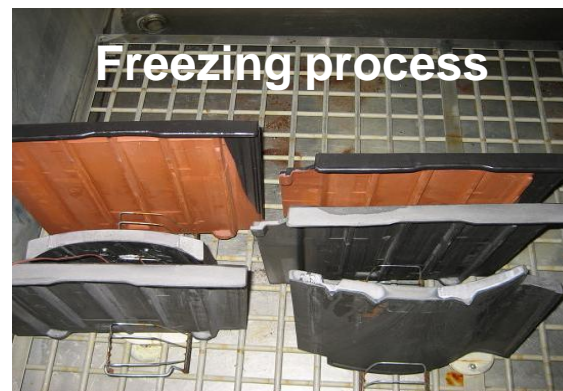
- Testing apparatus : According to JIS A 1435 'Test methods for frost resistance of exterior wall materials of buildings (Freezing and thawing method)'

Preconditioning
Immerse specimens
in water for 24 hours
→ nearly saturation

-20 °C cold air for 100 min

1 cycle
↔

10 °C water for 80 min

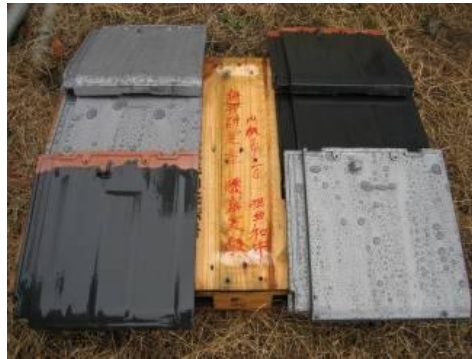
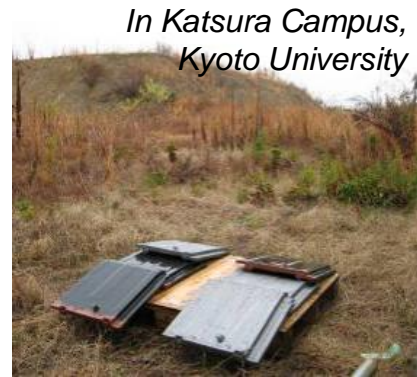
■ Experiment under outdoor conditions

non-uniform distribution

*In Katsura Campus,
Kyoto University*

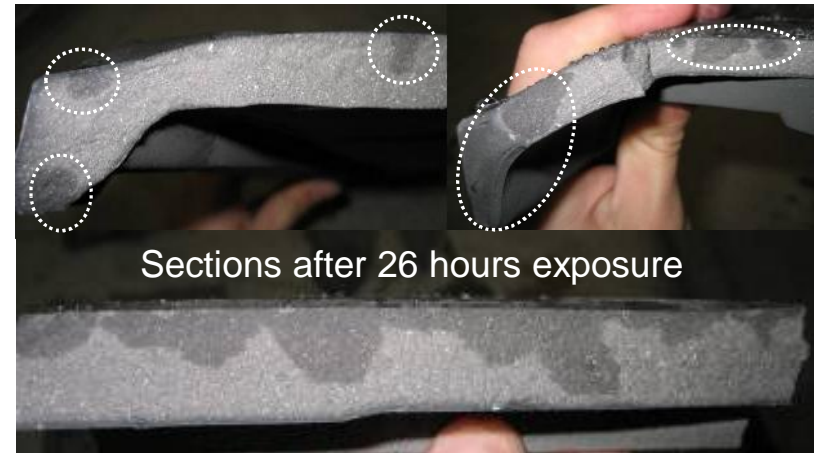
Sections after 26 hours exposure

◆ Weather: cloudy with intermittent rain.

The area that absorbed water is clearly distinguished

- ◆ The results of water absorption experiments showed that the water content might increase locally due to random invisible pinholes in the surface finish, and the results were confirmed by a simple numerical analysis.

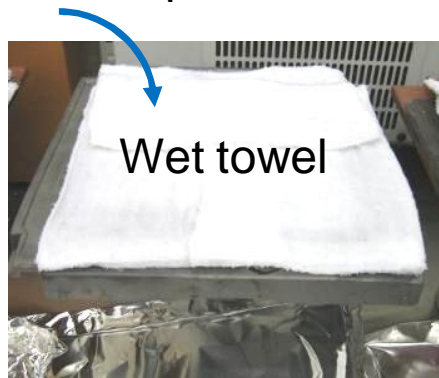
■ Laboratory experiment

non-uniform distribution

Water replenishment

Wet towel

after 9 hours

Does water penetrate through invisible pinholes on the surface finish ?

after 3 days

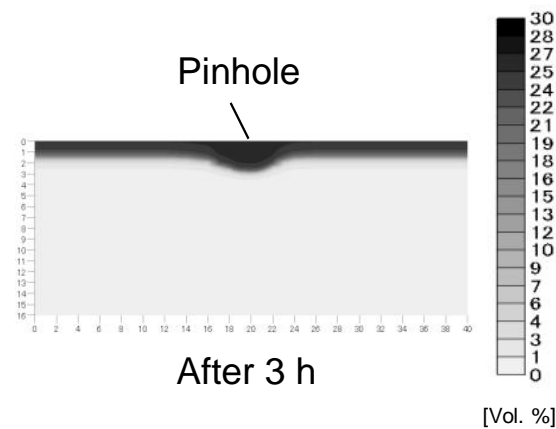
- The laboratory experiment is simulated using the equations of simultaneous heat and moisture transport. .

Does non-uniform moisture distribution lead to damage such as minor spallings ?

If invisible pinholes are randomly distributed on the surface finish, the moisture content will show non-uniform distribution.

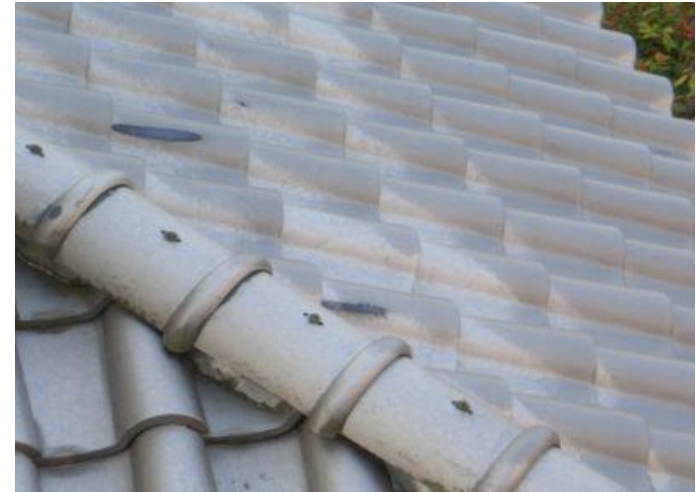
- A roof is usually open to the sky.
- The roof surface temperature is significantly influenced by night-sky radiation.
- The temperature drop causes surface condensation on the roof tiles, which can be seen especially in the early morning.
