Rising damp, a reoccurring problem in basements – a case study with different attempts to stop the moisture

Eva B. Møller, Danish Building Research Institute / Aalborg University Birgit Olsen, ALECTIA

Object School from 1965:

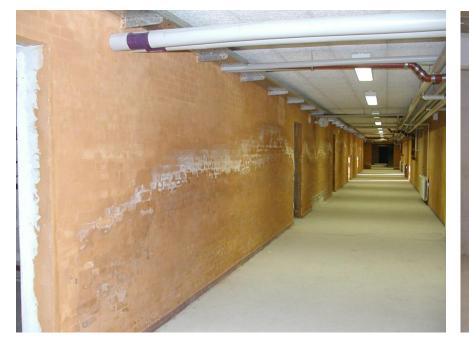
2002 Rising damp in internal walls

- Higher groundwater level (above new floor)
- Steel plates do not stop water under pressure
- No anti-flood valve between the drains
- Drainage under new floor was blocked by ochre

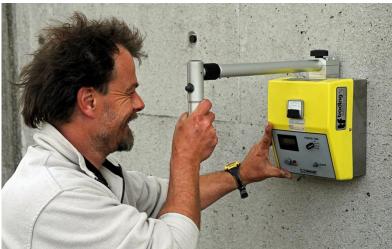
(Troxler)

Nuclear moisture density gauge Neutron radiation reflected by hydrogen atoms

- Nuclear moisture density gauge: High moisture: 21 weigh-% in brick and 6 weigh-% in mortar
- Microwave moisture measurements

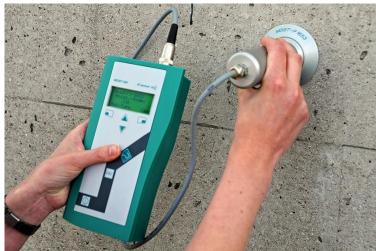
(hf-sensor)

Microwave moisture measurements

Reflected microwaves depend on dielectric properties of materials (high in water)
