Framtidens trähus Timber framed House of the Future

Moisture and mould in prefabricated timber frame constructions during production until enclosure of

Authors: Lars Olsson M.Sc., Kristina Mjörnell PhD, Pernilla Johansson M.Sc.
all from SP

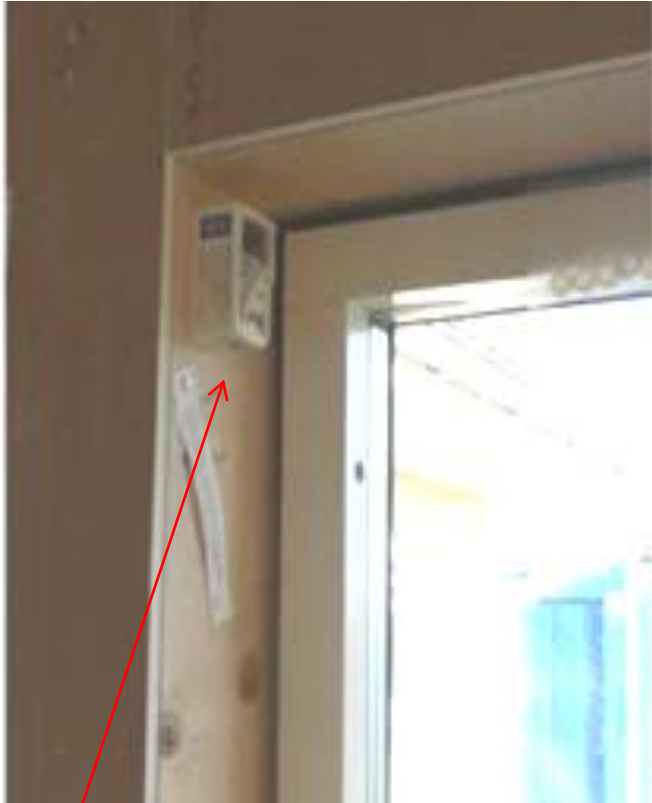
Loggers were placed inside of the wall on the stud

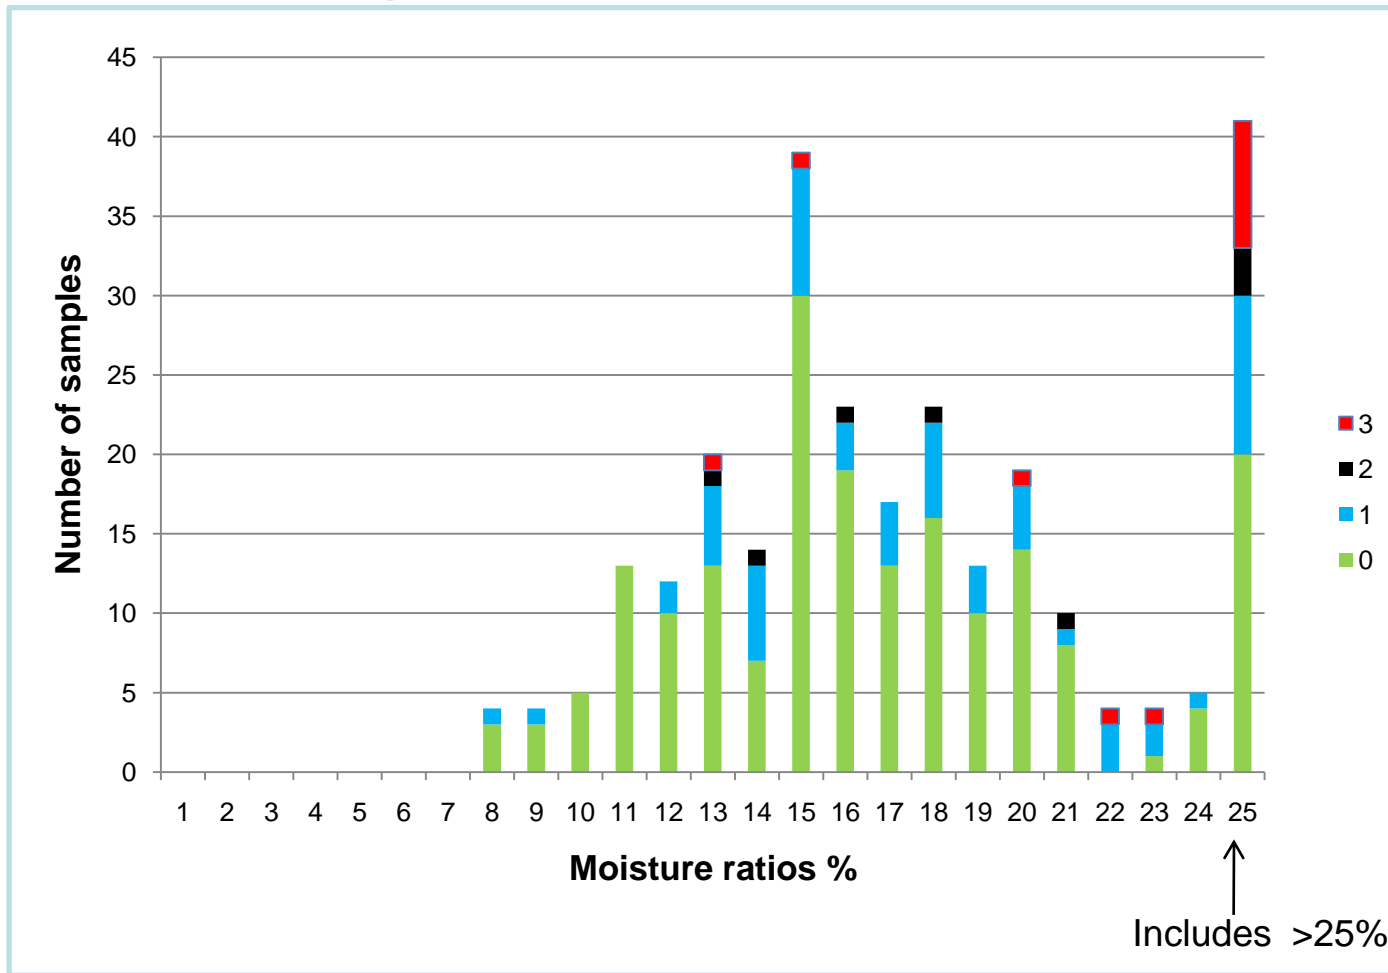
Mould growth and moisture ratio (MC)

Growth levels: 0 = no growth, 1 = slight growth, 2 = modest growth, 3 = extensive growth. 3-point scale from samples from the field

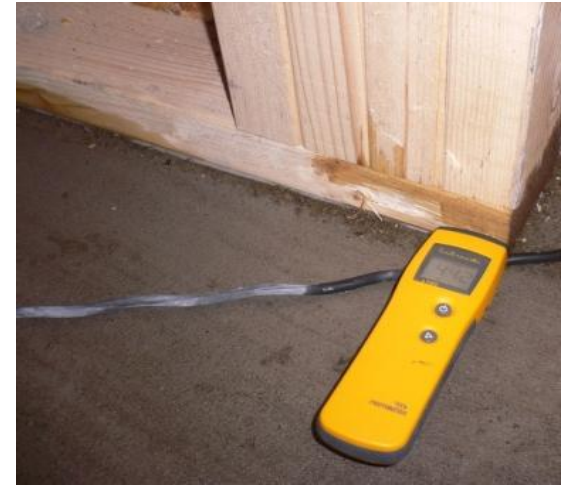
Recommendation

There is a risk that material becomes wet (most critical part is sills) and can be reduced by :

- modifications of the design (replace to moisture-resistant materials)
- Or appropriate changes to the method of erection
- Or better weather protection or coverage of the site.
- Also need for sealed joints for wind barrier.
