Deterioration of building envelope of wooden apartment buildings built before 1940 based on external survey

Paul Klõšeiko, Tõnis Agasild, Targo Kalamees Chair of Building Physics and Architecture, Tallinn University of Technology, Estonia

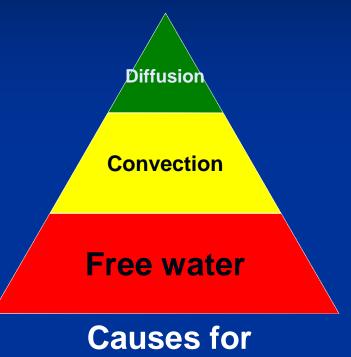
moisture damages

Wood is not very moisture-tolerant and brings easily all mistakes out;

The most critical factor in degradation of wooden buildings was free water;

Nevertheless, in many cases designers still concentrate mainly on vapour diffusion;

Required renovation within 10 years:

New	New	Foundation wall	New	At least 3 of the
cladding	roofing	renovation	windows	previous combined
37%	52%	71%	17%	23%
