## **Is the ventilation of timber façades essential?**

**Daniel Kehl, Severin Hauswirth, Heinz Weber**

R+D «Timber and Composite Construction»

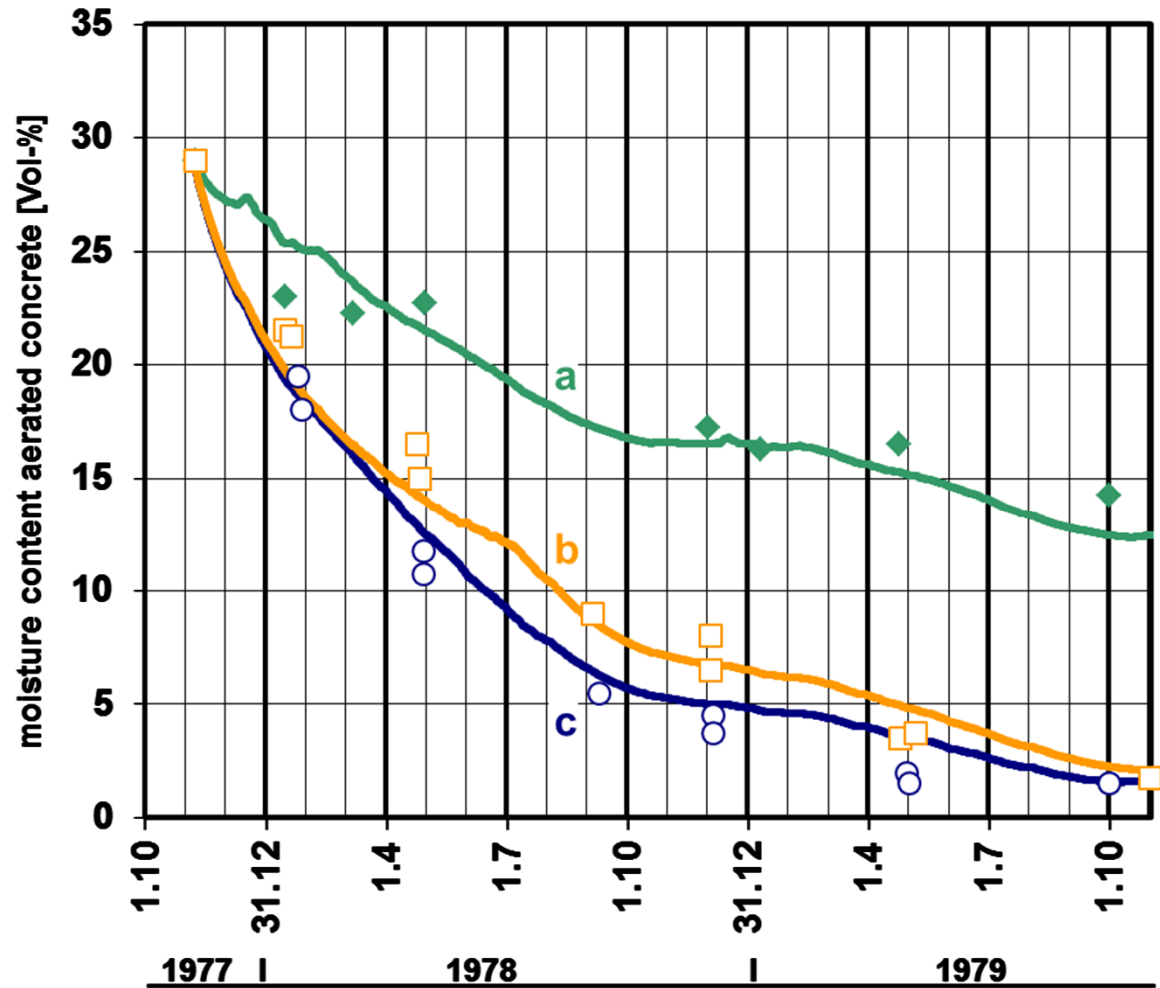
## Drying out of the wall (aerated concrete)

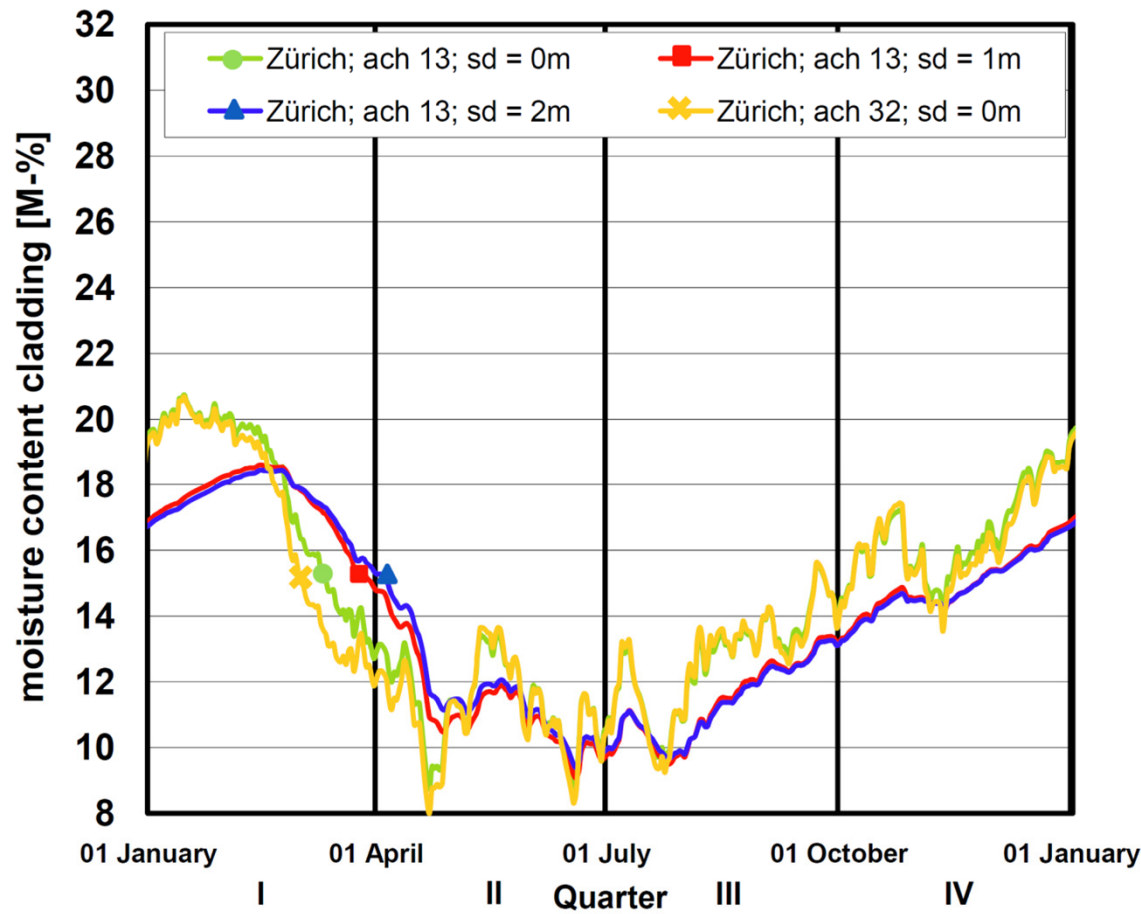
## Moisture content façade [M-%]

- Orientation North
- Zürich
- 13 and 32 ach
- 1 % wdr back side

steady state

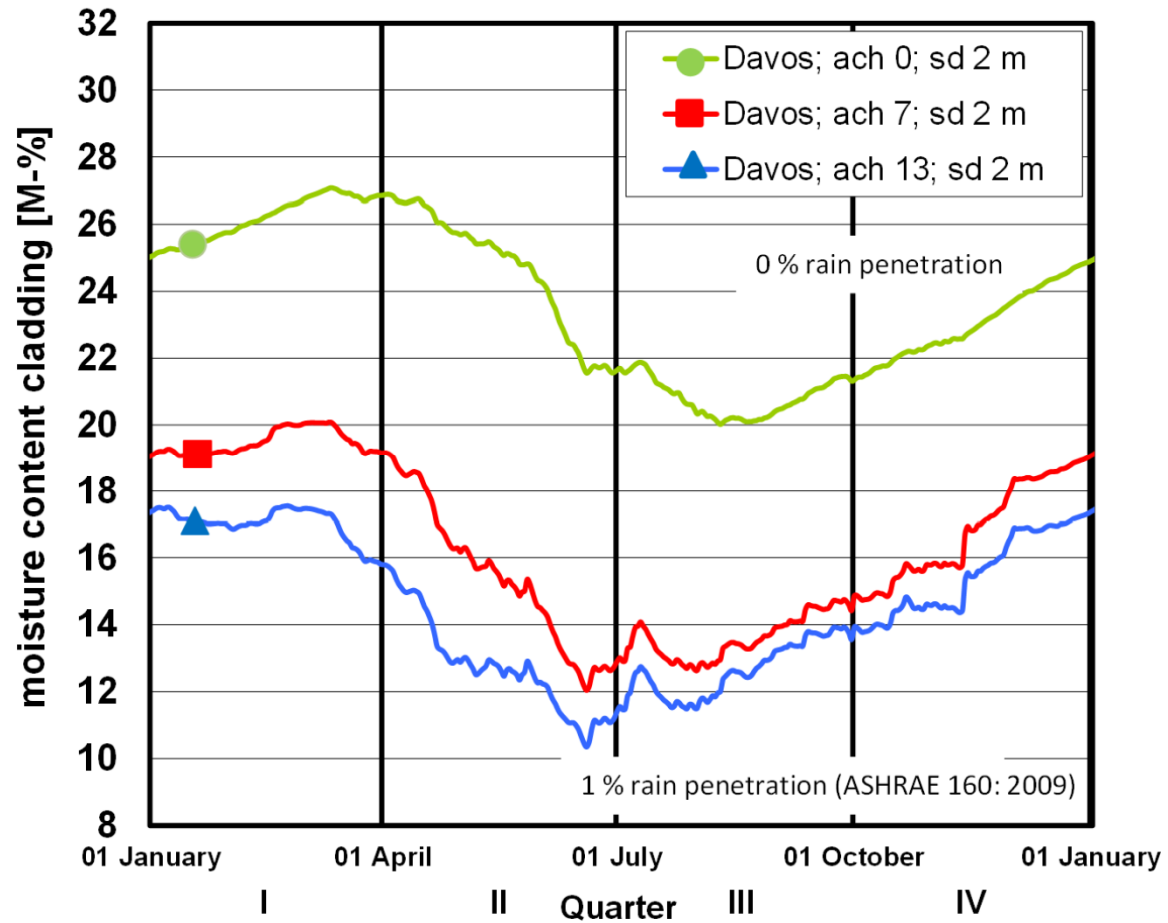
## Moisture content façade [M-%]

- Orientation North
- Davos
- 0, 7 and 13 ach
- 0 and 1 % wdr back side

steady state

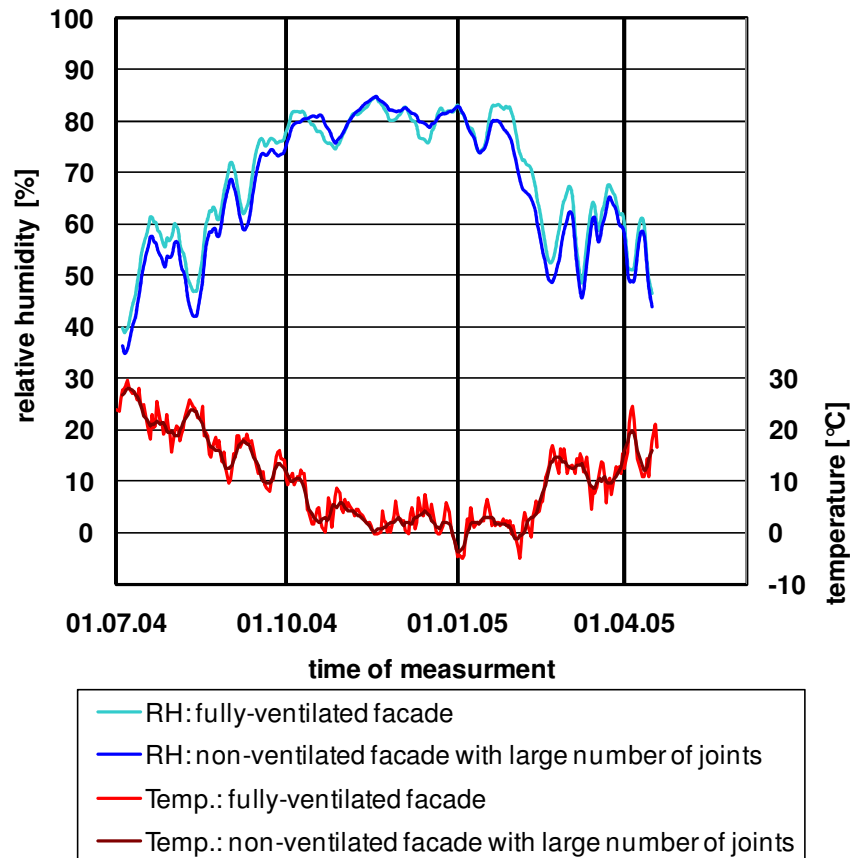
# Field test in Rain (CH)

RH and Temp. in the air space:  
ventilated and non-ventilated façade  
with large number of joints

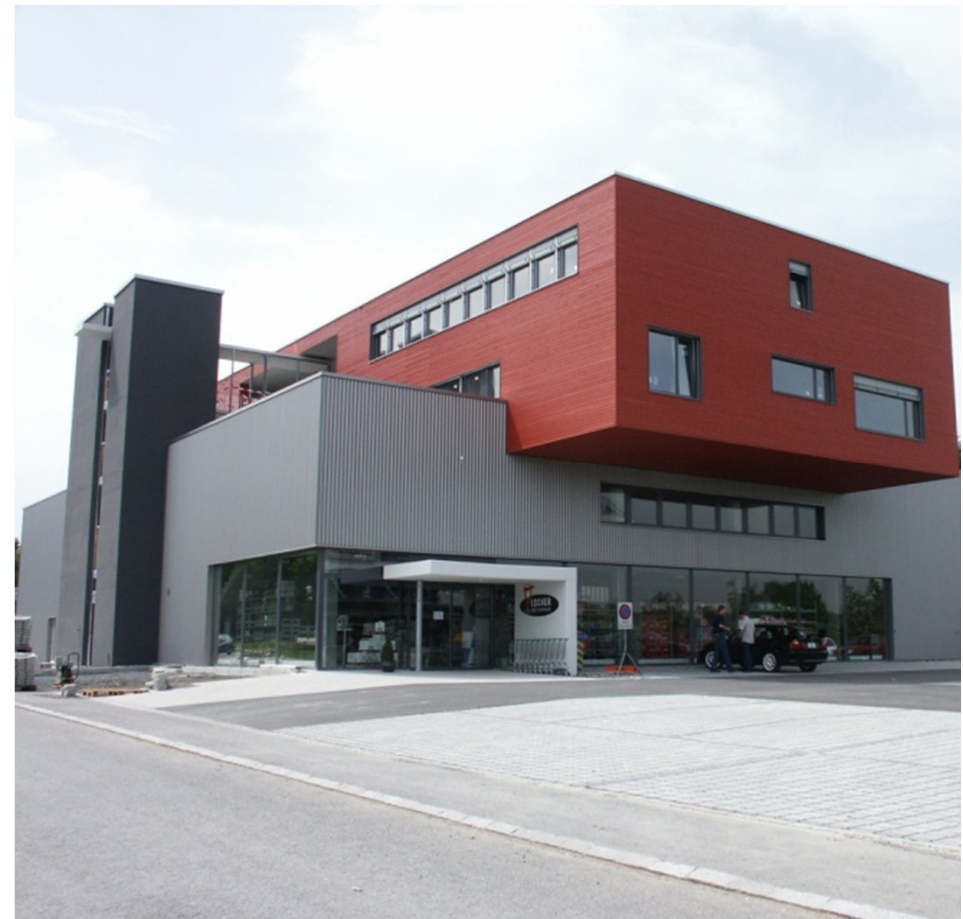
“**Gewerbegebäude Grossweid**“, Rain  
Timber construction engineer: Pirmin Jung
